SUBJECT: Govro Lake Dam Phase I Inspection Report  
(MO No. 31095)

GOVRO LAKE DAM

MISSOURI INVENTORY NO. 31095

PHASE I INSPECTION REPORT  
NATIONAL DAM SAFETY PROGRAM

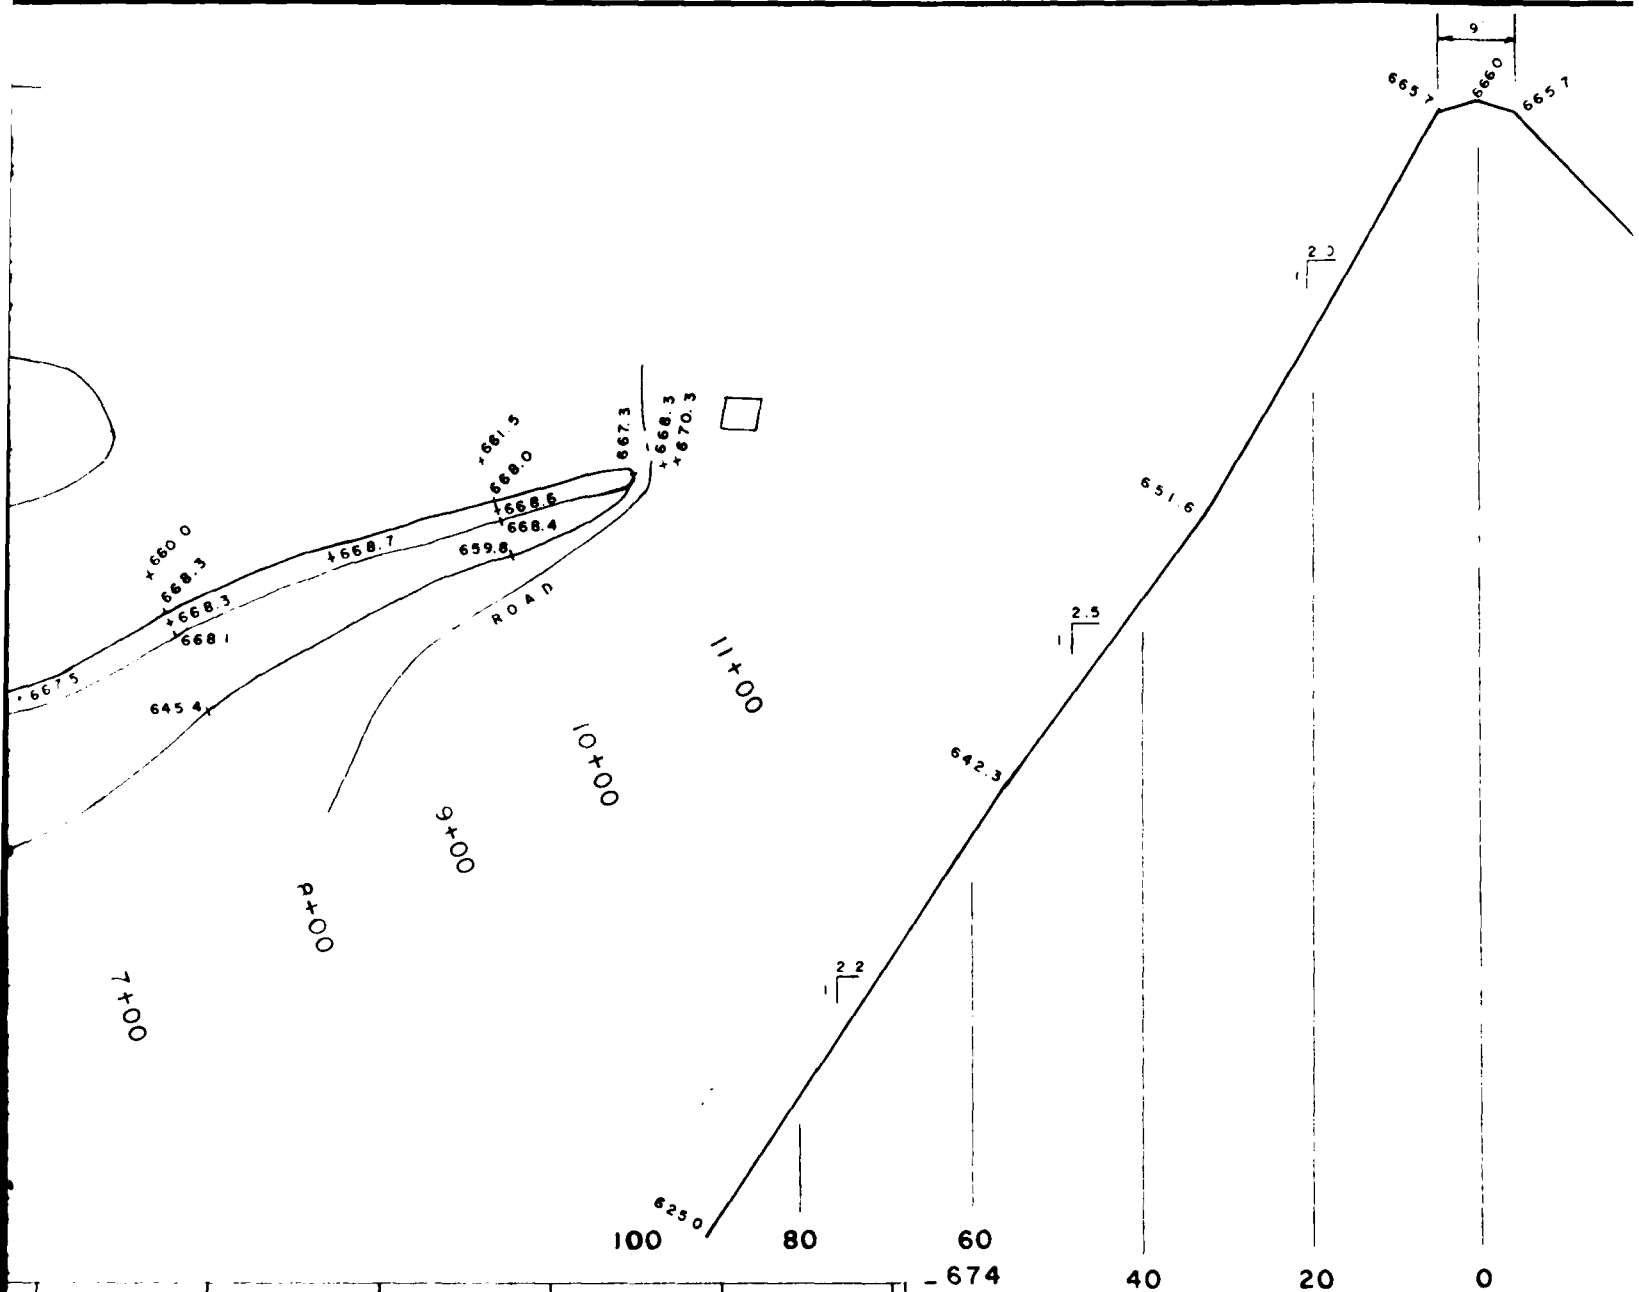
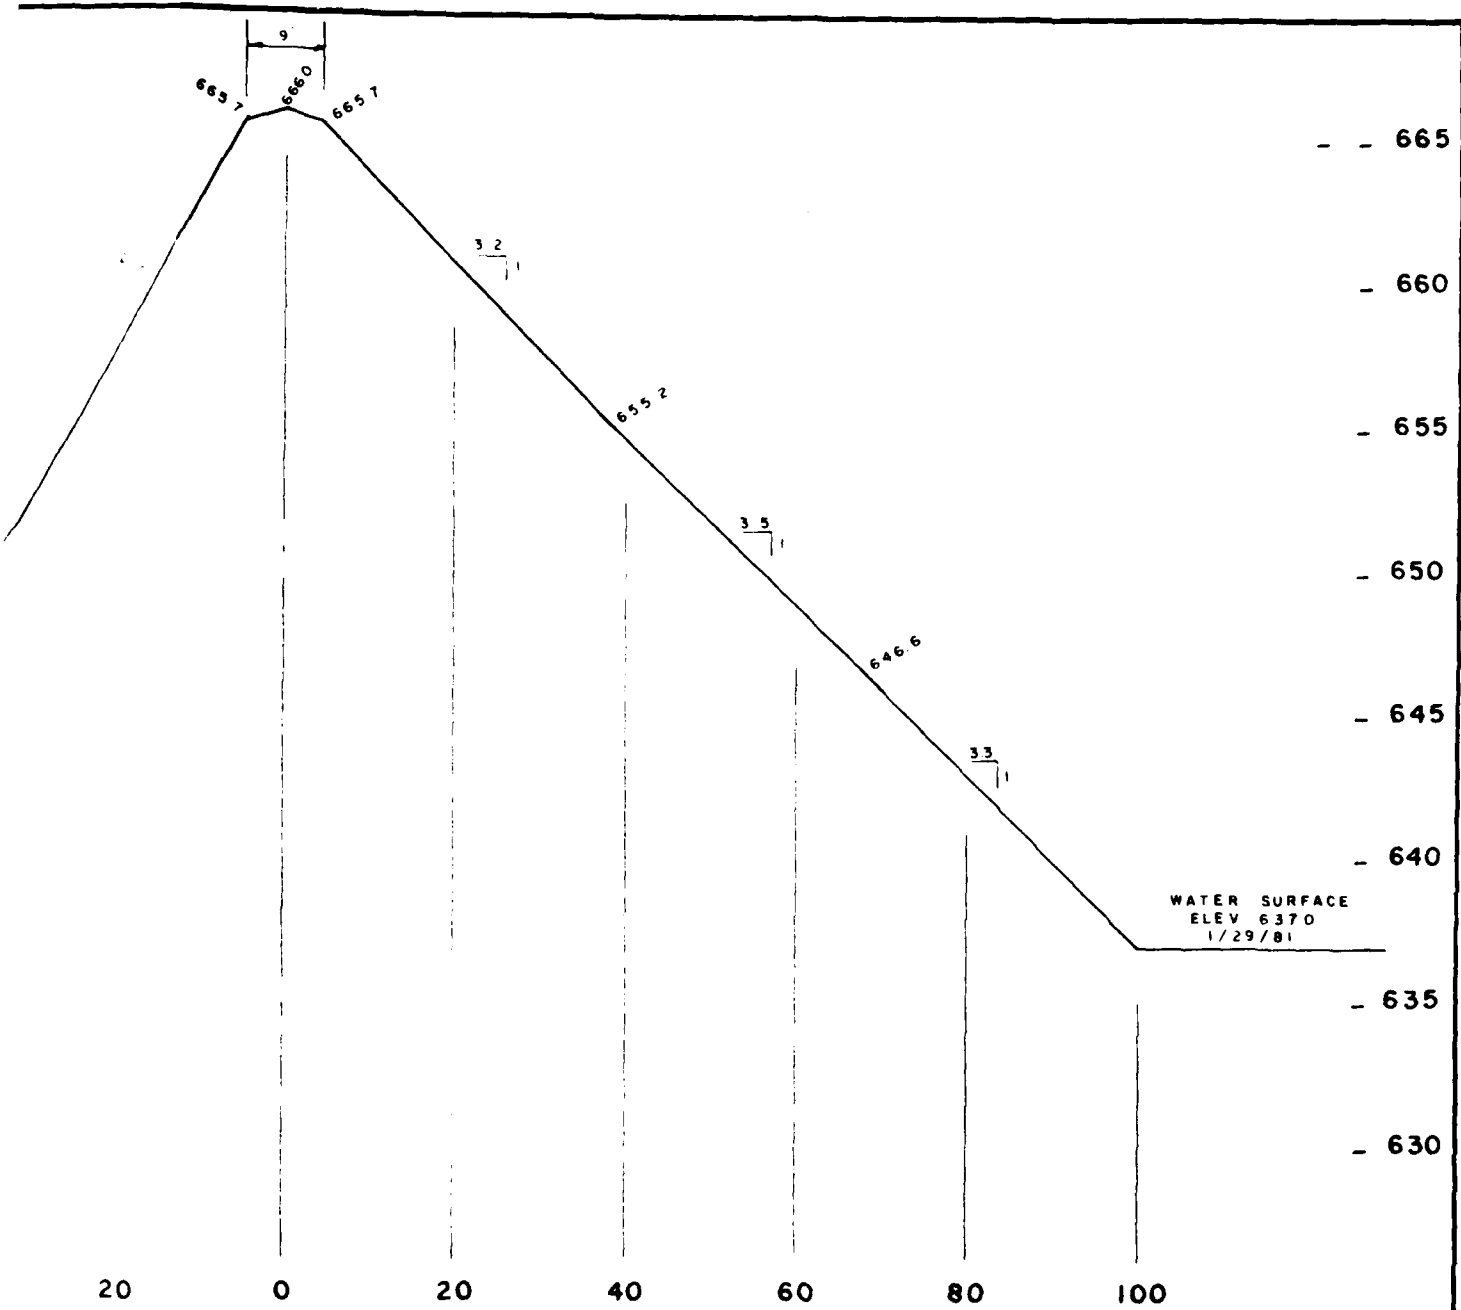
SECTION A-A STA 4 + 00

The embankment appears to be in good condition with grass cover noted on the upstream and downstream slopes of the embankment. The 9 foot wide crest of the embankment was grass covered. The embankment was constructed with a gentle sweeping curve downstream of the lake. The vertical alignment along the crest was irregular, sloping downward from the abutments to the center of the dam. Near the center of the embankment a definite low area was noted (see sheet 3 of Appendix A). The elevation of the top of dam varied from 669.5 (North abutment) to 666.0 (Station 4+00). The low point of the crest, elevation 666.0, was 1.6 feet below the principal spillway crest, elevation 667.6.

The slopes of the embankment were relatively constant. The upstreams slope varied from 1V on 3.2 H to 1V on 3.5 H. The downstream slope varied from 1V on 2.0 H to 1V on 2.5 H. No surface cracking of the embankment was noted. The junctions of the embankment and the abutments appeared good. No significant erosion, sloughing or other unusual movements were noted. No animal burrows were observed.

Small trees and brush growths were observed on the upstream slope at and slightly above normal pool elevation (elevation 637.0). Scattered small tree growths were observed on the upstream and downstream slopes of the embankment.

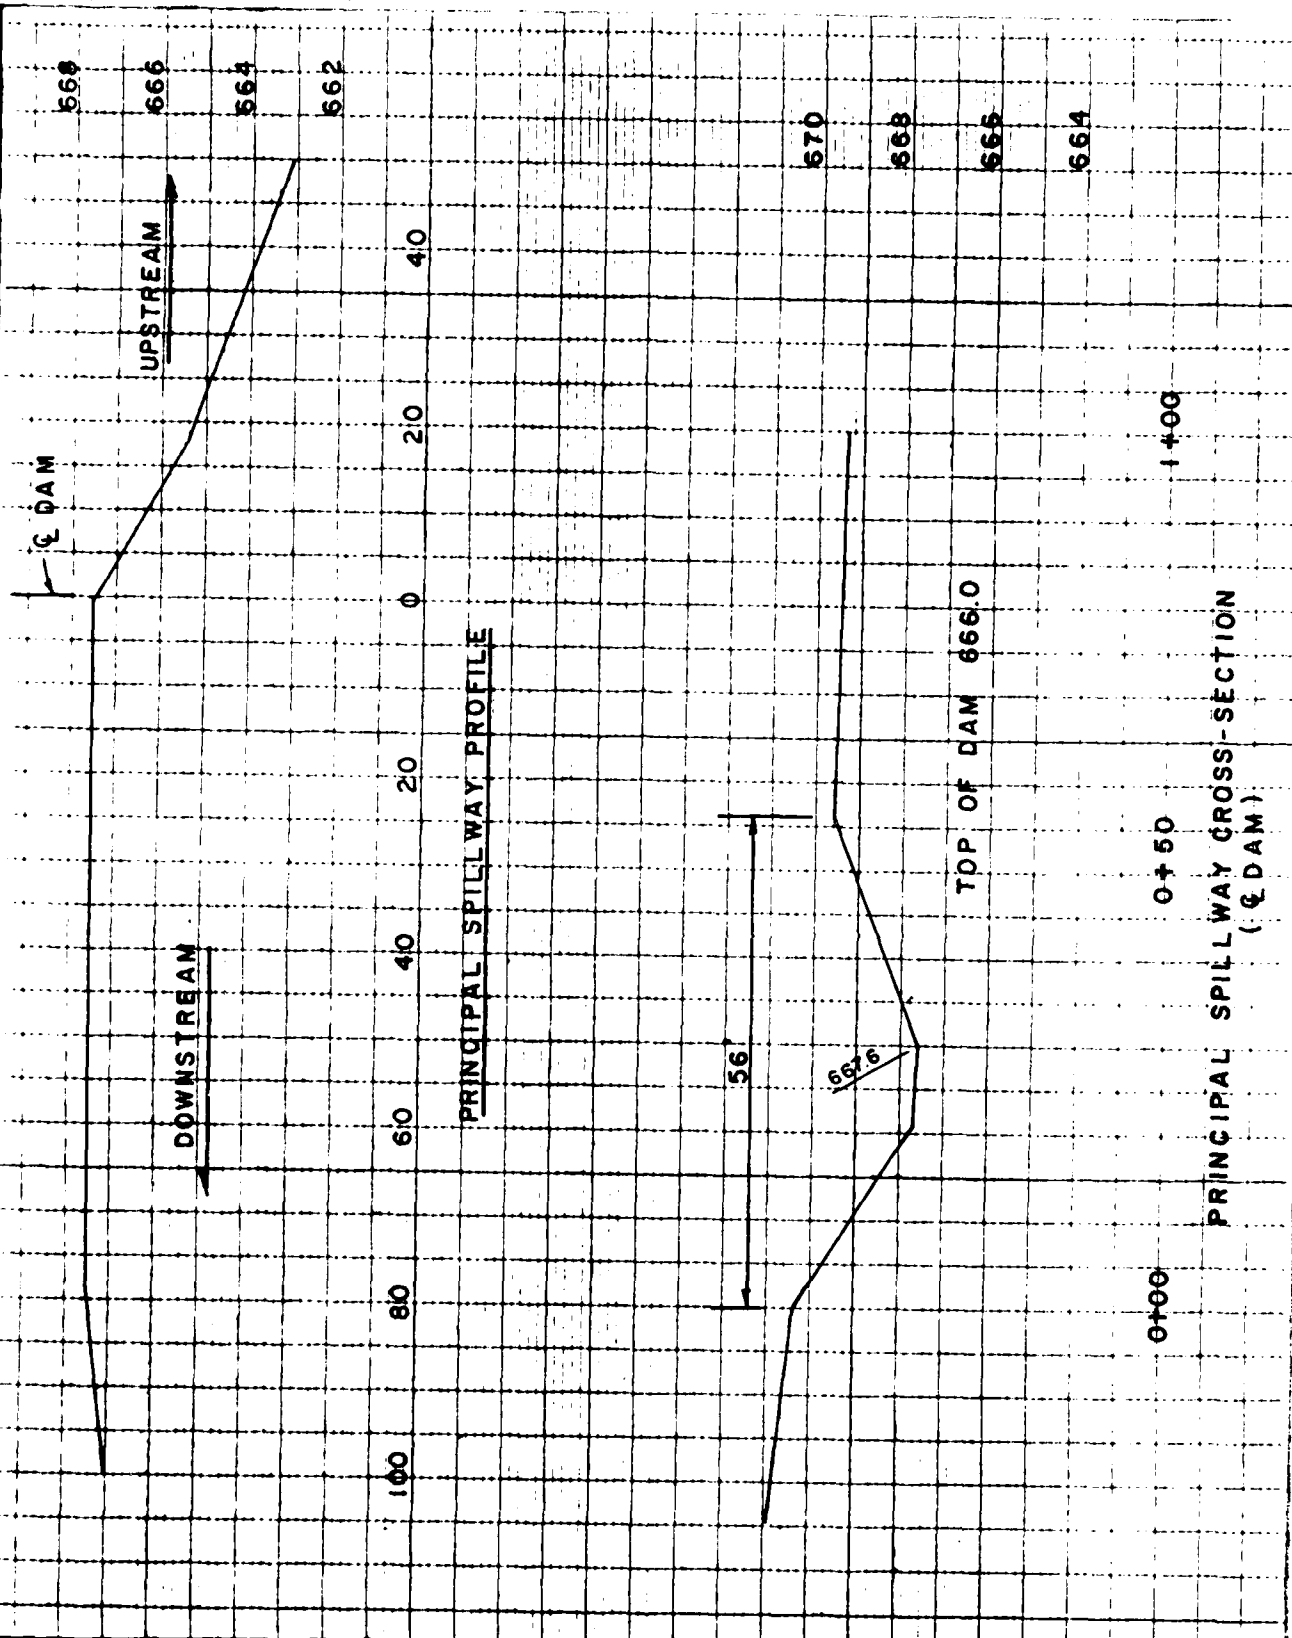
**SHEET 4, APPENDIX A**

The crest of the principal spillway is 1.6 feet above the low point of the dam. Overtopping of the dam would occur before any discharge is carried by the spillway. The approach to the spillway is clear. The leakage of the reservoir appears to be the major factor in the low normal pool level. The principal spillway channel is well separated from the embankment, and if used, spillway releases would not be expected to endanger the dam. The downstream channel is well defined with tree and brush growth noted.
